Experimental and Finite Element Analysis of Corroded High-Pressure Pipeline Repaired by Laminated Composite

High-pressure pipeline; composite repair; ASME PCC-2; ISO 24817

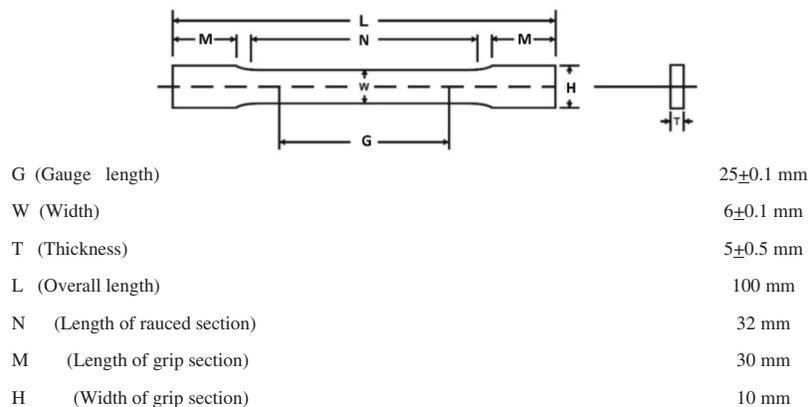
Figure 1: Sample size for tensile test

The mechanical properties of the pipe including yield strength, ultimate strength and module of elasticity were obtained by preliminary tests performed according to the ASTM E8/E8M standards. The stress-strain diagram of a sample of pipe material with the specifications mentioned in Fig. 1 is shown in Fig. 2. To mitigate the statistical dispersion, the tensile tests were performed 4 times and the mechanical properties were calculated as average of the preliminary test results. An image of the test can be observed in Fig. 3.

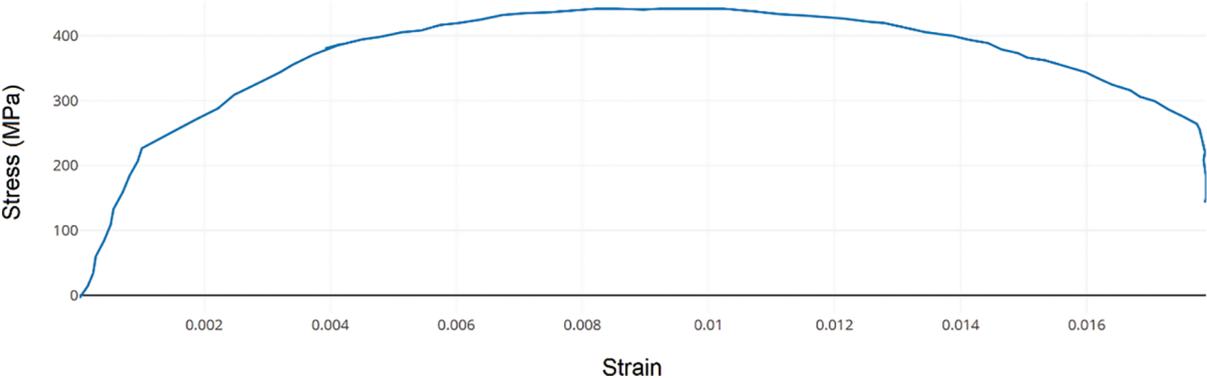
Figure 2: Stress-strain diagram of tensile test

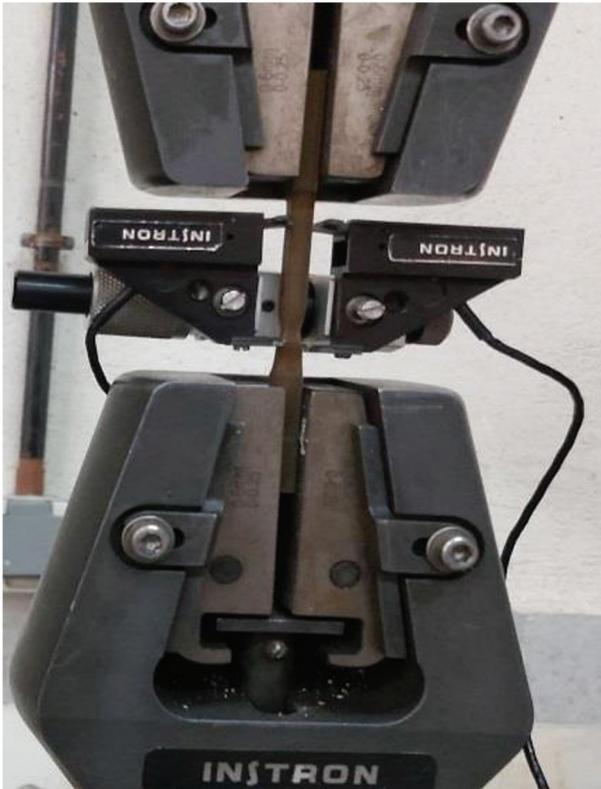
Figure 3: Tensile test on the sample

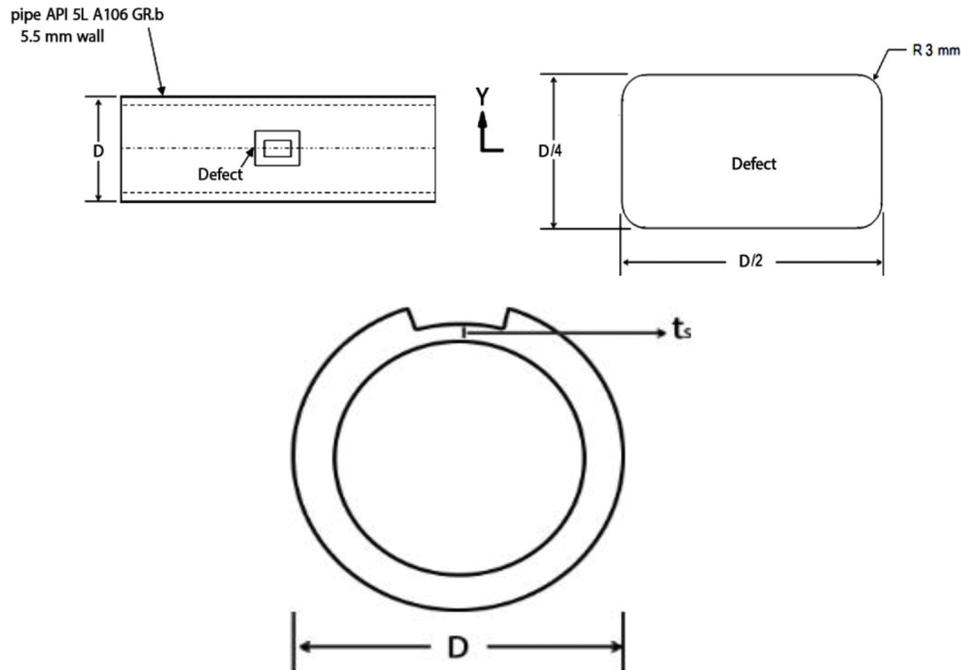
Figure 4: Defective pipe design

During the first phase of the experiment, the intact vessel was connected to the hydraulic device and the internal pressure was increased. In the second phase, a defect was created on the outer surface of the pipe. The defect was designed according to the ASME PCC-2 [27] standard with a depth of 70% of the thickness. In Fig. 4a, sketch of the cavity geometry is shown. Also, an image of the defect can be seen in Fig. 5.

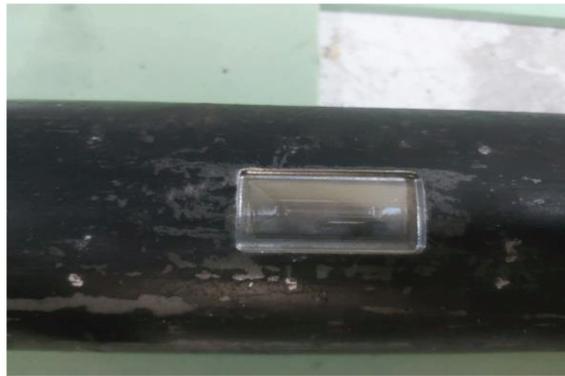
Figure 5: Defect created on the tank

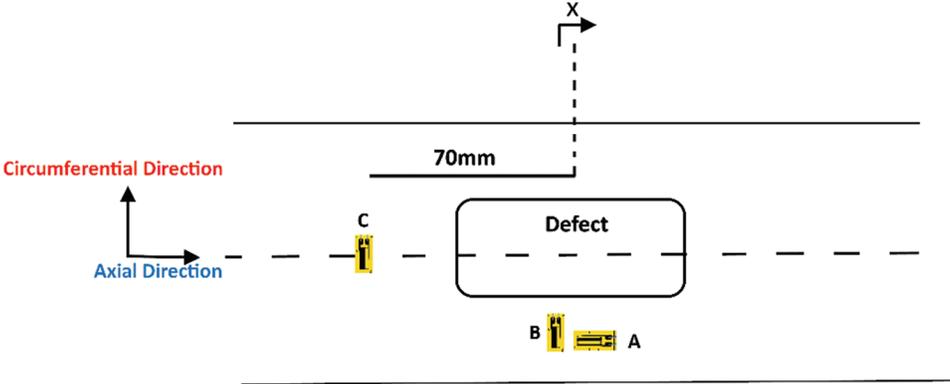
Figure 6: Strain gauge coordinates on the defective tank

In order to measure the strain and the stress accordingly, the tank was equipped with strain gauges, as shown in Fig. 6. These were positioned on the outer skin of the pressurized tank and connected to a graphical user interface system. In this way, it was possible to monitor and register the stress level in the tank thickness in real-time during the experiments. According to the coordinates system of Fig. 6, the axial strain gauge A and the circumferential one B are positioned in the critical region near the

defect, and the peripheral strain C is located at a distance of 70 mm from the defect, along the axial direction.

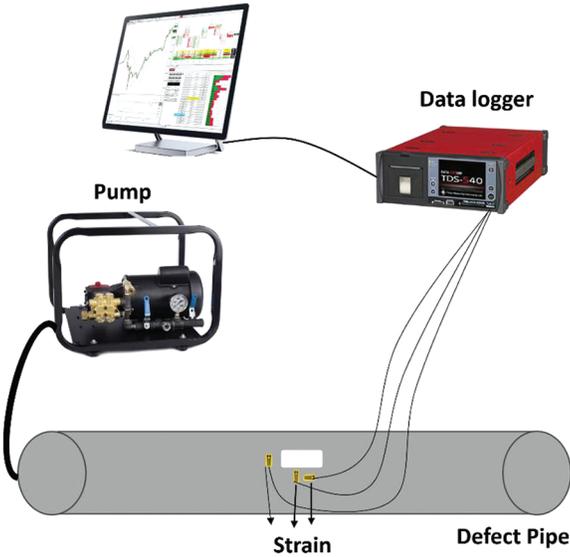
Fig. 7 is a schematic representation of the experimental test rig. The tank is equipped with strain gauges which, in turn, are connected to the Data Logger through soldered wires. The tank is joined with the high-pressure hose of the hydraulic pump and filled with hydraulic oil. With this apparatus, it is possible to monitor the internal pressure of the oil as well as the stress and strain level of the tank on display. Fig. 8 shows the defective tank under test, fully equipped with the strain and pressure gauges.

Figure 7: Schematic diagram of a defective pipe test

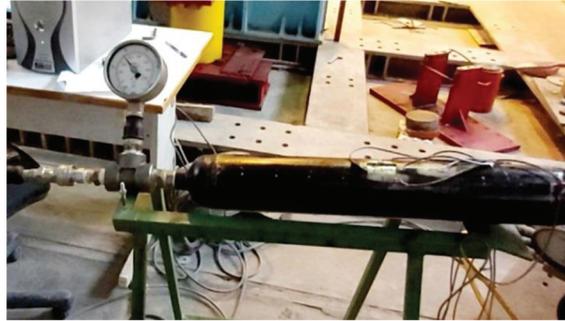
Figure 8: Defective pipe test

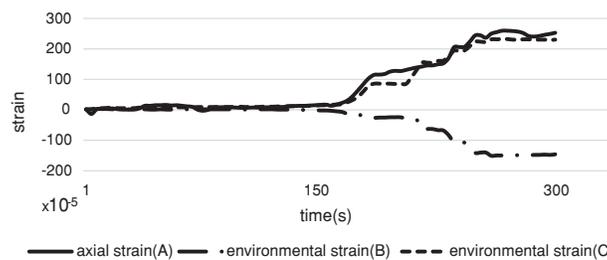
Fig. 9 shows the strain evolution during the test measured by the three strain gauges in the defective pipe. In areas close to the defect, due to geometric changes and non-uniformity of the area, the axial strain (gauge A) is higher than the peripheral strain (gauge B). In fact, the axial gauge detects tensile deformation whereas the circumferential one reveals a compressive deformation. The peripheral strain gauge positioned in C is stretched due to its distance from the defect.

Figure 9: Axial and environmental strain measured during the experiment

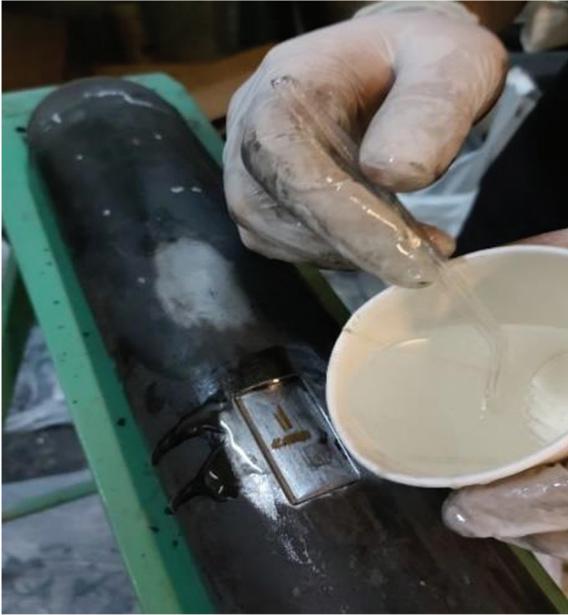
Figure 10: Filling the artificial defect with hardener resin

As shown in Figs. 10–12, to repair the defective tank and reduce the strain and concentration of stress in the cavity area, first, the inside of the defect is filled with filler material and then the metal tank is repaired by screwing the composite fabric reinforced with glass fibers. Generally, the filler material is flexible and has a high compressive strength which enables the transmission of the internal stress from the pipe to the composite. In this study, for the first time, it was used as filler material, a mixture of resin and hardener. Next, the surface of the pipe and the composite layers are impregnated with the hardened resin mixture. Thereafter, the layered composite fabric is wrapped onto the defective pipe to reach the minimum thickness of the repair layer as designed by ISO-standards [15] and following the prescriptions of several ASME-standards [18,27–32].

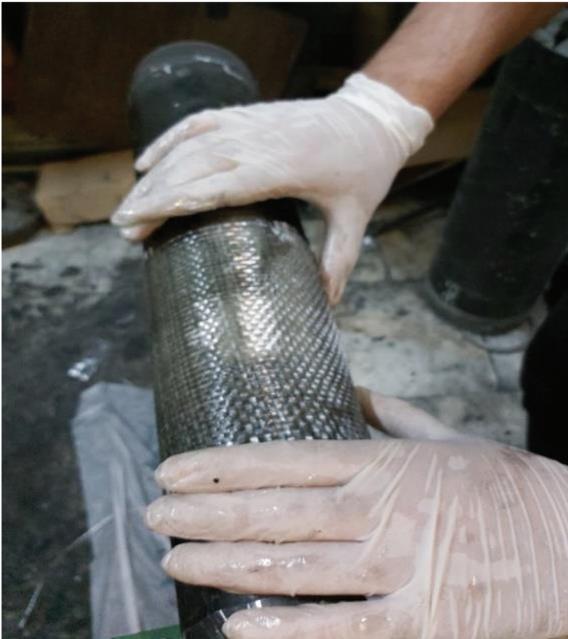
Figure 11: Impregnation of composite layers with resin

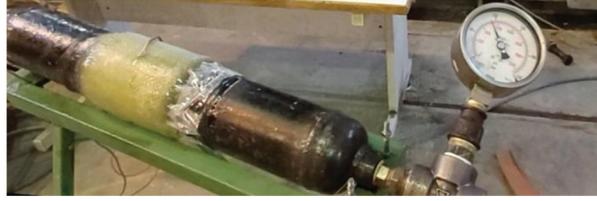
Figure 12: Pipe repaired with Glass Fiber Reinforced Polymer (GFRP) under internal pressure

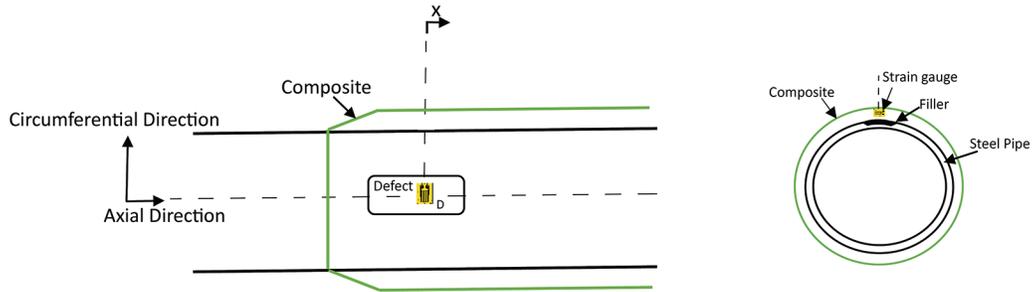
Figure 13: Strain gauge coordinates on the repaired tank

Once the installation of the composite screw was finished, a perimeter strain gauge was attached to the composite fabric as shown in Fig. 13. This was needed to monitor the strain in the repaired area during the final test under the action of the internal pressure.

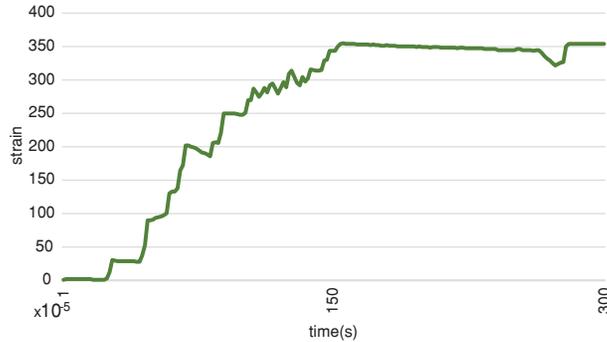
Fig. 14 is a diagram of the circumferential strain evolution of the repaired pipe. The hoop strain was tensile throughout the duration of the experiment, and it presented an increasing trend with the internal pressure. As the defect is repaired, the discontinuities are removed and the cylindrical relations between longitudinal and hoop strain are re-established with the hoop strain being greater than the axial one.

Figure 14: Peripheral strain diagram of the repaired tank

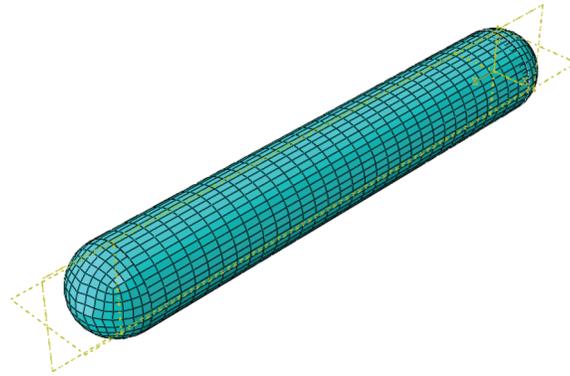
Figure 15: Pipe modeling in the mesh module

The pipe sample used for the tests was modelled by means of the finite element software ABAQUS as shown in Fig. 15. First, the cylinder geometry and the two hemispherical caps were created and then merged together with a tie constraint. The mechanical properties were defined according to Table 3 and an internal pressure of 10 MPa was applied on the internal surface of the pipe.

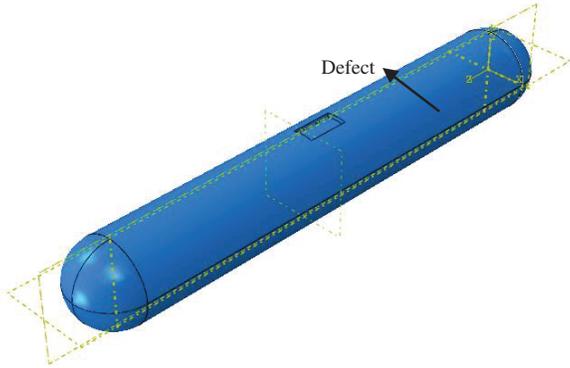
Figure 16: Tank corrosion in modeling

To simulate the defect in the tank, 70% of the pipe wall thickness, located at the middle pipe length as shown in Fig. 16, was removed in accordance with ISO 24817 standard. In accordance with the experimental test conditions, the internal pressure was set to 90 bar.

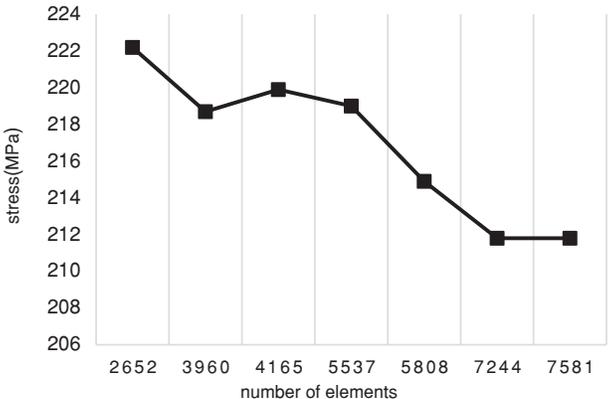
Figure 17: Convergence of the element at the location of the pipe defect

The geometry of the specimen was meshed using second-order hexahedral elements (C3D20). The final mesh was obtained after a convergence analysis, made on the number of elements required in the area surrounding the defect. The converged mesh was made up of 7581 20-node brick elements of type C3D20, as shown in Fig. 17.

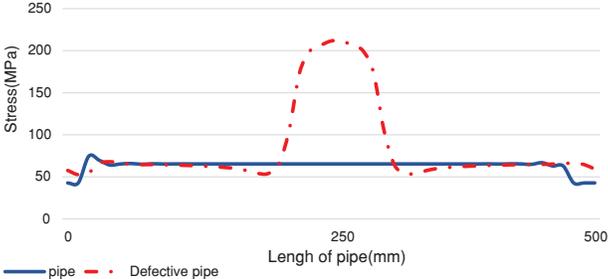
Figure 18: Comparison of stress diagrams in healthy and defective pipes

In Fig. 18a, comparison of the von Mises stress distribution along the pipe length is presented for both intact and defective pipe. The portion of pipe under analysis is the area surrounding the defect along the axial direction. It can be seen that within the area of thickness reduction, the stress remarkably increases (by a factor of 4) with respect to the intact vessel. The area directly close to the outer edge of the defect faces a rapid reduction of the stress due to the sharp geometry change. Thus, the presence of the defect has only a local effect as the stress level reaches the non-defective stress level.

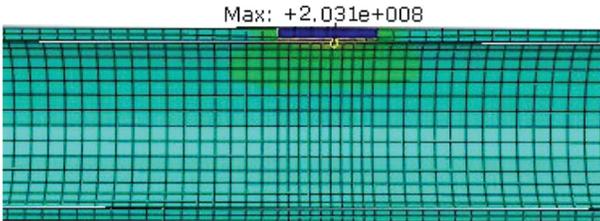
Figure 19: Placing the filler in the defect of the pipe

The repair was modelled by means of the finite element software as well as shown in Figs. 19 and 20. The filler resin was inserted in the defect and assembled through a tie-type constraint to the defective pipe geometry. On top of this, a layer of GFRP composite fabric, having a thickness calculated according to Eqs. (17) and (18), was modelled and tied to the global model. The mechanical properties of both the resin and the composite layer were defined according to Tables 3 and 5. The diagram of Fig. 21 shows the von Mises stress trend along the pipe’s axial direction for all the configuration under analysis: intact pipe, defective pipe, pipe reinforced with filler resin and pipe repaired with GFRP composite fabric. The diagram shows that the stress concentration decreases by 4% as consequence of the filler resin reinforcement; the reduction increases to 22% after the GFRP composite fabric insertion. A further enhancement of the repaired vessel is shown in Fig. 22. Here, it is visible the circumferential strain reduction by 62% with respect to the pipe configuration before the repair.

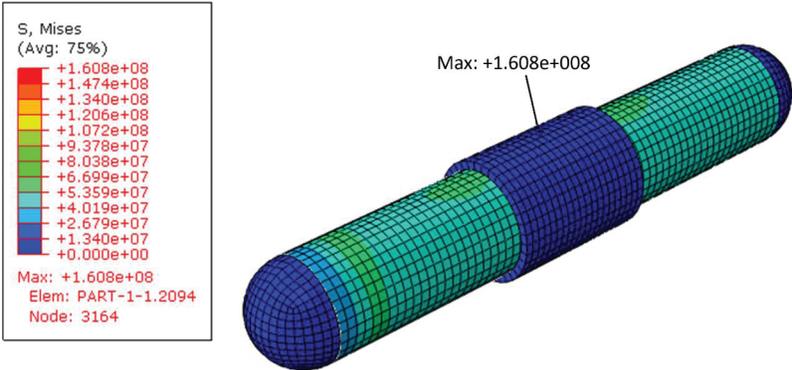
Figure 20: Final view of repairing a defective pipe with the help of composite in mesh module

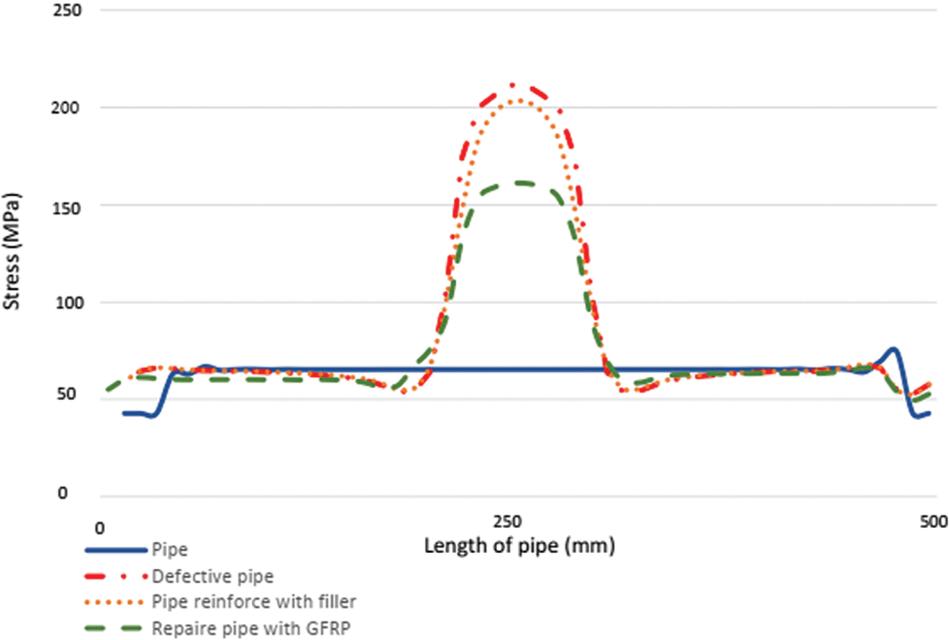
Figure 21: Comparison diagram of stress distribution in healthy, defective, filler-reinforced and composite-repaired pipe

The results of the finite element analyses demonstrate the substantial improvement in structural integrity achieved through the combined application of filler resin and GFRP composite fabric. As shown in Fig. 21, the stress pick is reduced by 4% due to the filler resin reinforcement. This reduction further increases to 22% following the GFRP composite fabric application. Fig. 22 further illustrates the effectiveness of the repair by showing a 62% reduction in circumferential strain compared to the unrepaired pipe.

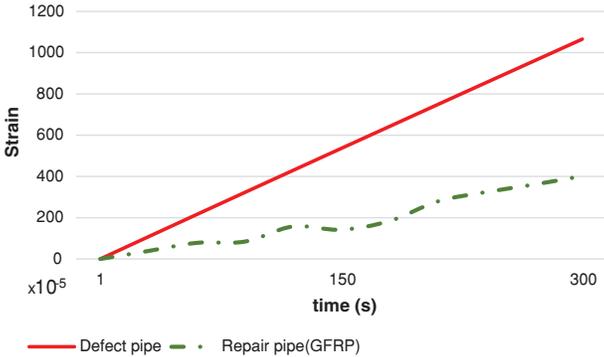
Figure 22: Peripheral strain diagram in the pipe before and after repair

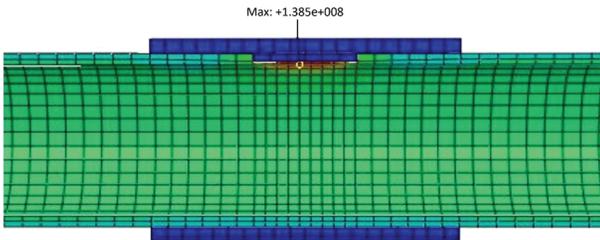
Figure 23: Stress in a pipe repaired with CFRP composite

In order to assess the effect caused by the use of a different woven composite fabric, it was created a numerical modelled of the pipe having an outer repair layer made of CFRP fibers instead of the GFRP one. The calculation of the minimum thickness of the layer required, performed as per Eq. (14), showed that the CFRP layer is more than 50% thinner than the GFRP layer. With the CFRP configuration, the simulation results showed a 12.5% reduction of the von Mises peak stress with respect to the GFRP one; in addition, also the circumferential strain presented a reduction of 25% in the supplementary configuration. The simulation image and its results can be seen in Figs. 23–27. In addition, a comparison of experimental and numerical strain of defective pipe and repaired pipe is shown in Table 6.

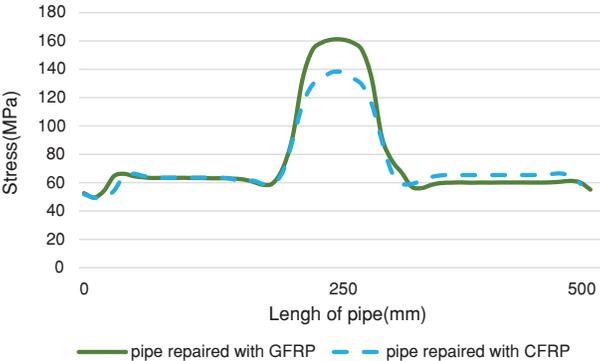
Figure 24: Comparison diagram of stress distribution in a pipe repaired by GFRP and CFRP composite fibers

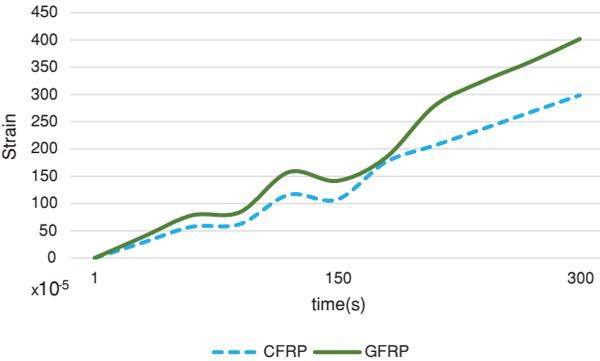
Figure 25: Comparison diagram of circumferential strain in a tank repaired with the help of composite with GFRP and CFRP fibers

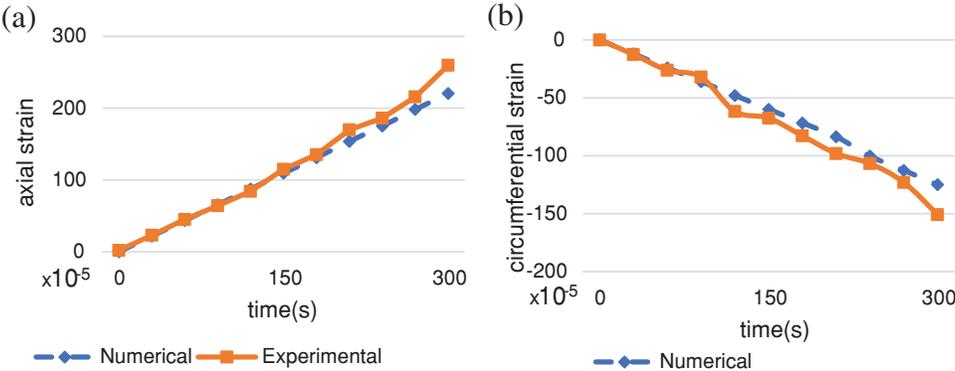
Figure 26: Comparison of experimental and numerical strain of defective pipe: (a) axial strain at point A (b) circumferential strain at point B

Figs. 26 and 27 report the axial and circumferential strain comparison between tests data and numerical results. Due to the defect's geometry, the axial gauge A and the circumferential one C detect a tensile and increasing trend during the experiment, whereas a compressive and downward trend occurs for the circumferential strain gauge B. The numerical analyses were able to reproduce the experiments both in terms of strain values and trend. The numerical-experimental agreement is complete in the initial part of the test whereas, during the second half of the experiment, a mismatch arises. The maximum error between experimental data and numerical results was detected by the circumferential strain gauge B, corresponding to a value of 17% as per Table 6. Also, in Fig. 26, the correspondence in the axial strain diagram, gauge B, between experiments and numerical analyses is spotless over the first 100 s of the test. According to the coordinates of the strain gauge in Fig. 27, it can be seen that the peripheral strain C is located at a distance of 70 mm from the center of the defect. As shown in Fig. 27, due to the distance of this strain gauge from the defect location-the peripheral strain C was

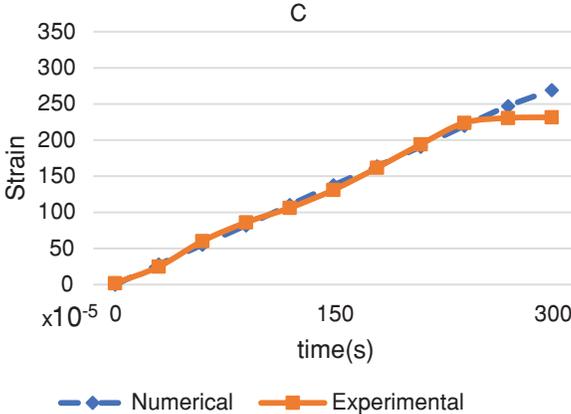
Figure 27: Comparison of experimental and numerical circumferential strain of defective pipe at point C

located at a distance of 70 mm from the center of the defect- the nonlinear effects and deformation are less evident. From the beginning to the time of 250 s, the two curves, experimental and numerical, match entirely, but in the end of the test, when the internal pressure was 90 bar, a maximum difference of 14% arises.

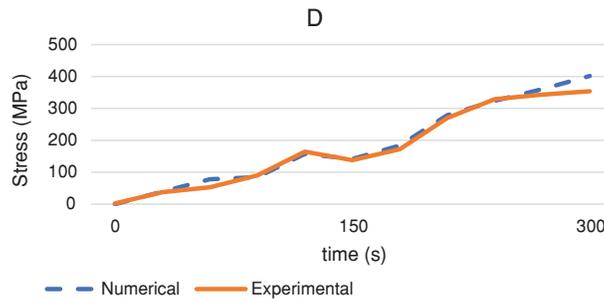
Figure 28: Comparison of experimental and numerical stress of repaired pipe at point D

As can be observed from the diagram of Fig. 28, there is a very precise agreement between numerical and experimental results of the circumferential strain. In fact, the maximum difference detected, always at the highest-pressure levels, was 11.8%. This could be explained by the fact that the reparation reduces the non-linearities related to the sharp variation of the geometry and as a consequence attenuate the stress pick; this secondary effect is not detected by the FE-analysis of the numerical model. An other explanation is that the high level of the internal pressure caused a fluctuations in the strain gauges measurement.
